Prospective Durability Testing of a Vascular Access Phantom

[Western Journal of Emergency Medicine, 11\(4\)](#)

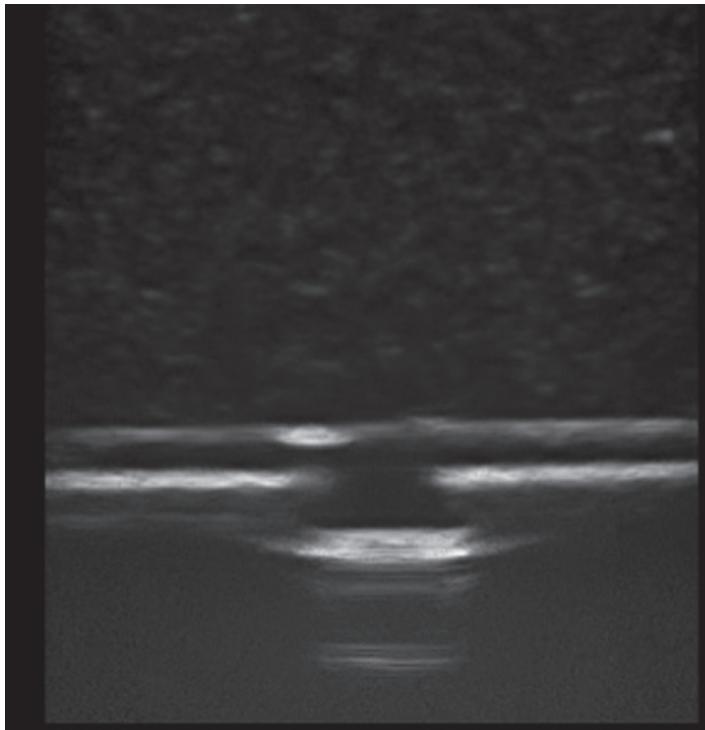
Figure 1. Image of the Blue Phantom™ rubber matrix placed over a two-tiered echogenic structure prior to any needle punctures.

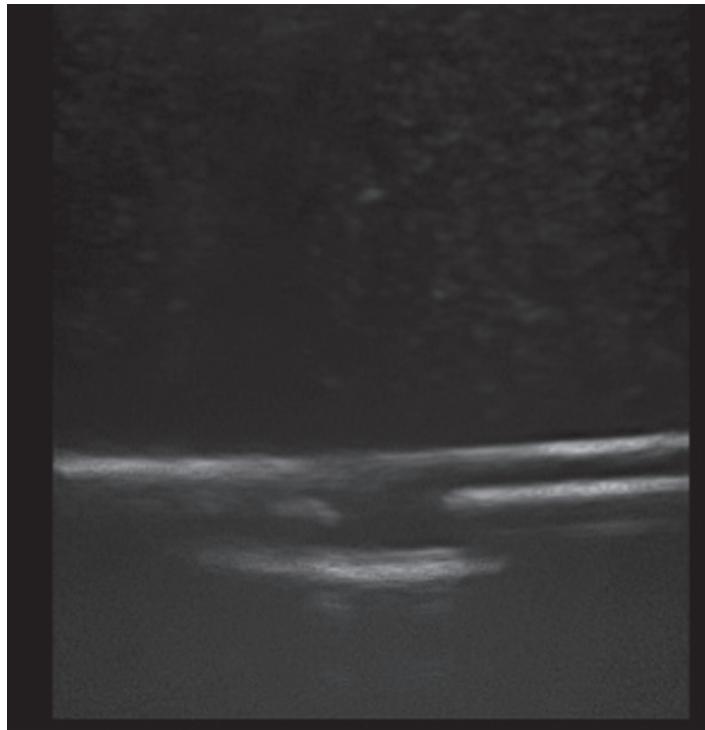
Figure 2. Image of the Blue Phantom™ rubber matrix placed over a two-tiered echogenic structure after 1,000 needle punctures in a 1 cm² area.

the target structure, but they remained visible after 1,000 needle punctures. (Figures 1-2)

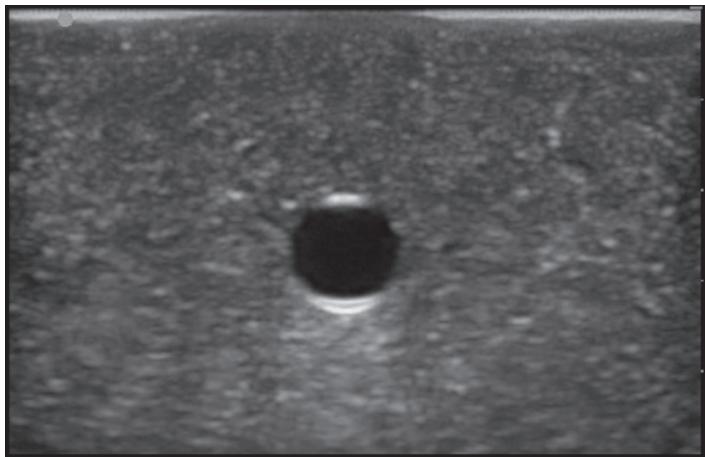
Figure 3. Short-axis image of the Blue Phantom™ rubber matrix and simulated vessel prior to any needle punctures.

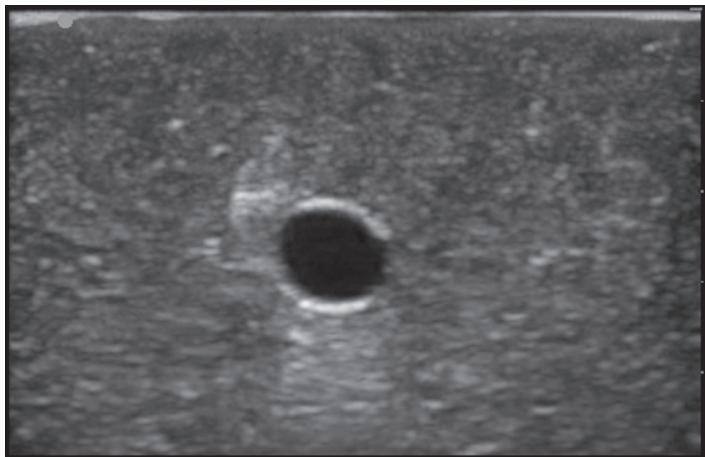
The second phase of the study demonstrated excellent acoustic transmission and image quality on both short- and long-axis images of the rubber matrix and simulated vessel after 1,000 needle punctures. The anterior and posterior vessel walls and needle tip were well visualized without any signs of vessel leakage on still images or with compression and power Doppler. (Figures 3-6)

Figure 4. Short-axis image of the Blue Phantom™ rubber matrix and simulated vessel after 1,000 needle punctures in a 1 cm² area.

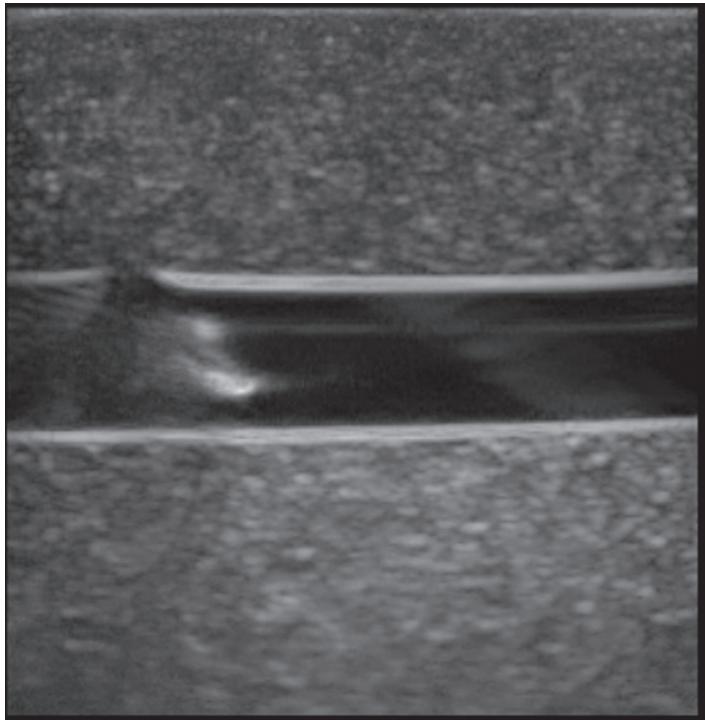
Figure 5. Long-axis image of the Blue Phantom™ rubber matrix, simulated vessel, and needle tip after the initial needle puncture.

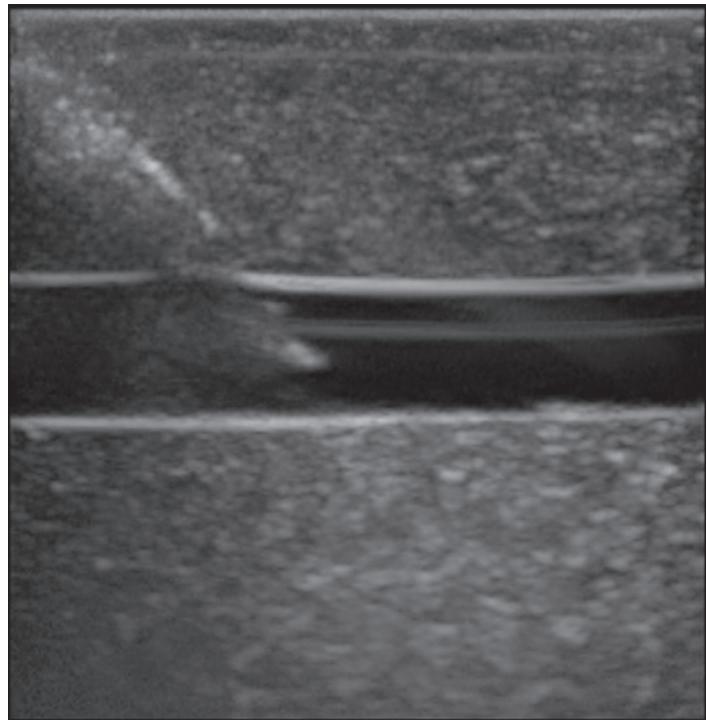
Figure 6. Long-axis image of the Blue Phantom™ rubber matrix, simulated vessel, and needle tip after 1,000 needle punctures in a 1 cm² area at a 45° angle.
